## technical bulletin

No TB-0009B, Release Date 02/14/2023

### Bar Gun Handle Leaks

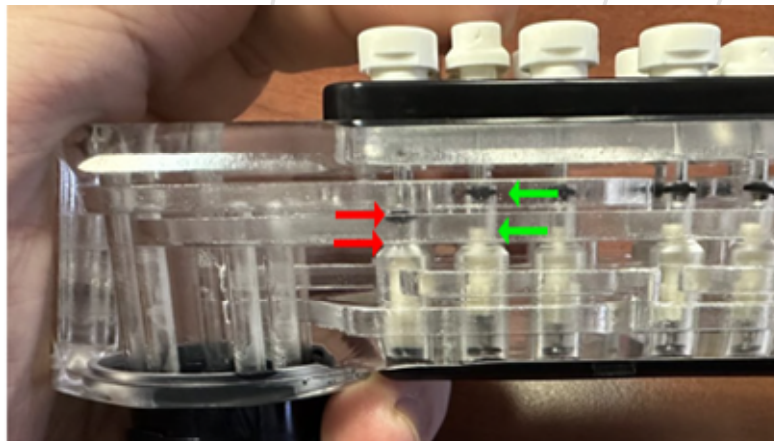
Taprite has been made aware of issues out in the field related to “stuck plungers” and has taken action to address this. Approximately 0.2% of handles shipped out in the last 3 years have been received for evaluation. We have confirmed the issue and identified that barguns manufactured in and around June of 2021 may be susceptible to it. The typical symptoms of a “stuck plunger” are slow-to-close buttons, or buttons that fail to close at all after dispensing product. This is almost always on the syrup channels but may happen as well on Soda and Water channels.

To properly diagnose the issue, technicians must review the plungers and O-rings are seated/located in the right position by looking at the handle from the sides.

In response to this issue, Taprite is developing a design improvement to prevent movement of the O-ring and eliminate the condition reported by the field.

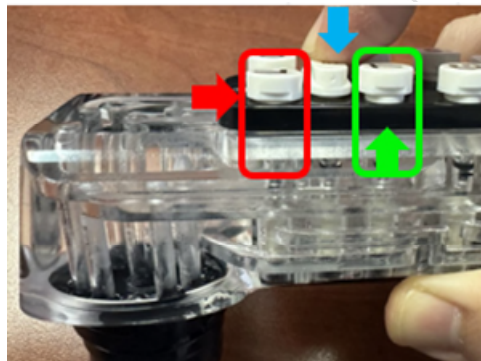
After shutting off product flow to the handle, if the soda and/or water buttons are operating appropriately, the technician may press down on those buttons and test for “spring back” on the syrup buttons around the water/soda. All syrup buttons should spring back up to the closed position by themselves while pressing down the soda/water button they are connected to.
