Technical Bulletin
No. TB-0009B, Revision Date 02/14/2023

Bar Gun Handle Leaks

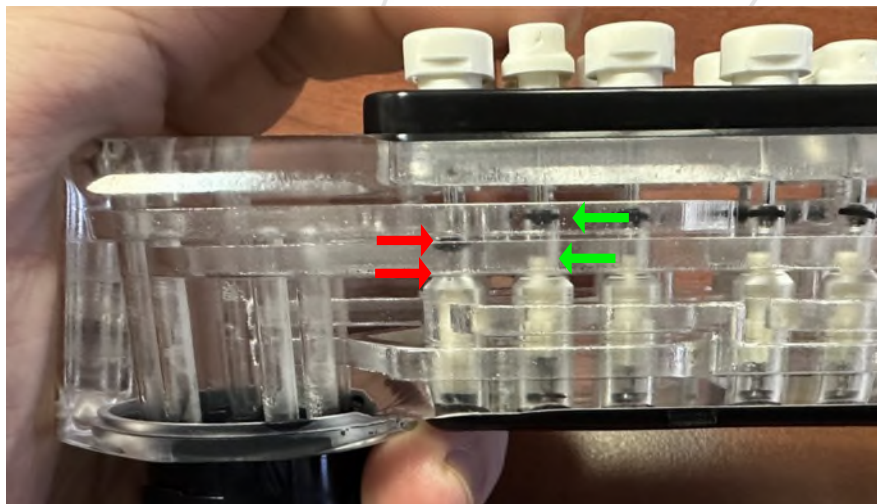
Taprite has been made aware of issues out in the field related to “stuck plungers” and has taken action to address this. Approximately 0.2% of handles shipped out in the last 3 years have been received for evaluation. We have confirmed the issue and identified that barguns manufactured in and around June of 2021 may be susceptible to it. The typical symptoms of a “stuck plunger” are slow-to-close buttons, or buttons that fail to close at all after dispensing product. This is almost always on the syrup channels but may happen as well on Soda and Water channels.

To properly diagnose the issue, technicians must review the plungers and O-rings are seated/located in the right position by looking at the handle from the sides.

In response to this issue, Taprite is developing a design improvement to prevent movement of the O-ring and eliminate the condition reported by the field.

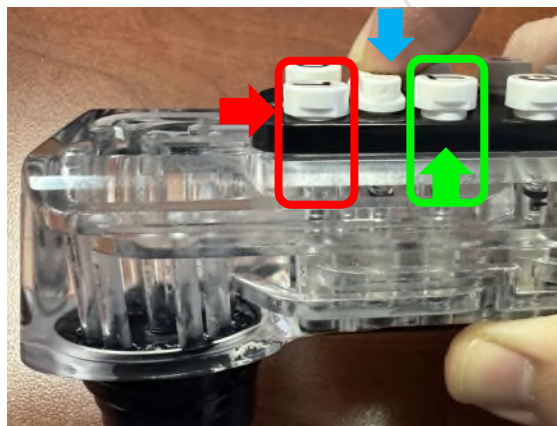
After shutting off product flow to the handle, if the soda and/or water buttons are operating appropriately, the technician may press down on those buttons and test for “spring back” on the syrup buttons around the water/soda. All syrup buttons should spring back up to the closed position by themselves while pressing down the soda/water button they are connected to.
