## technical bulletin

No TB-0010B, Release Date 05/15/2023

### Rattler Bar Dispenser O-Ring Removal and Replacement using Viton XP41 O-Rings

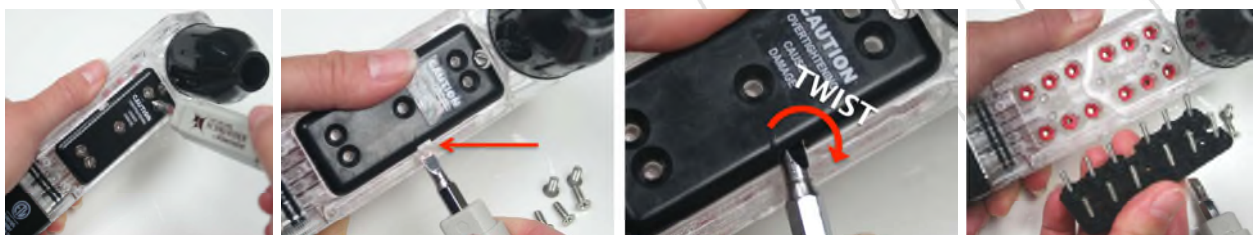
In instances where there have been syrup leaks through the dispense nozzle, O-rings and plunger assemblies should be replaced in accordance with Technical Bulletin TB-0009B (released February 2023). If the leaks are not resolved after proper seating of the O-rings per the bulletin's advice, the standard, black O-rings (part number 208-5003) should be replaced with blue O-rings in order to improve sealing and reduce the chance of O-ring "rolling".

Use the screwdriver to remove the 6-32 x 3/8" screws which hold the bottom plate in place. Units which have not been opened previously may have one screw covered by the "CAUTION Overtightening Causes Damage" sticker.

Pry away the plate to expose the plunger assemblies for removal. Keep the plunger springs attached to the bottom plate to ease reinstallation.
